NASA CR-188258

Final Report

THE MAGNITUDE OF IMPACT DAMAGE ON LDEF MATERIALS

Martha Allbrooks and Dale Atkinson  
POD Associates, Inc.  
2309 Renard Place, S.E.  
Suite 201  
Albuquerque, New Mexico 87106

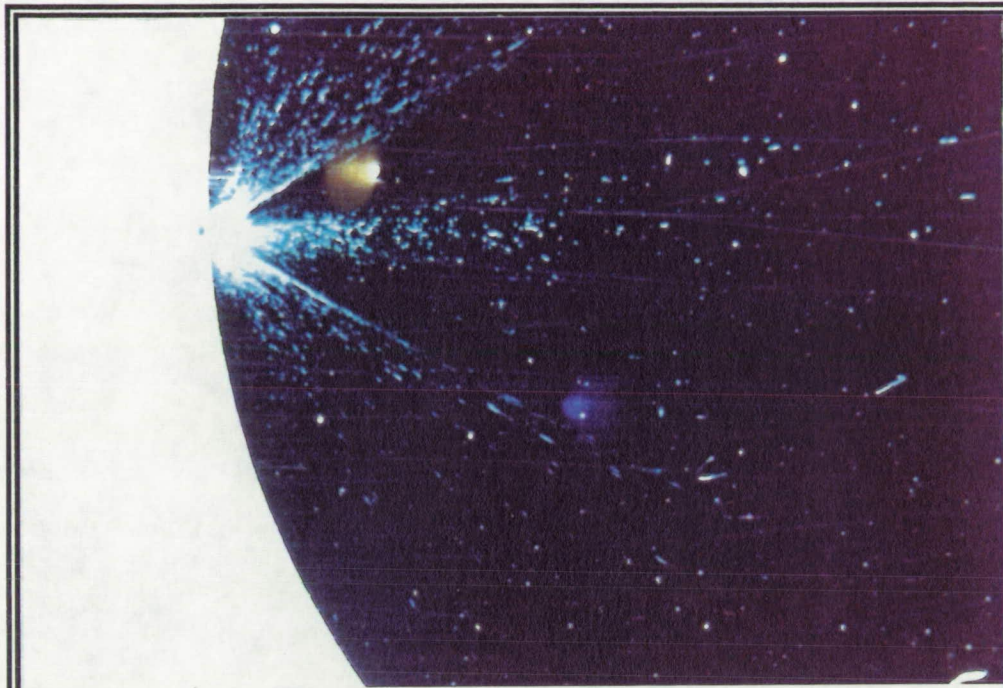
**Figure P2-57.** Photograph of ejecta spray across an optical surface.

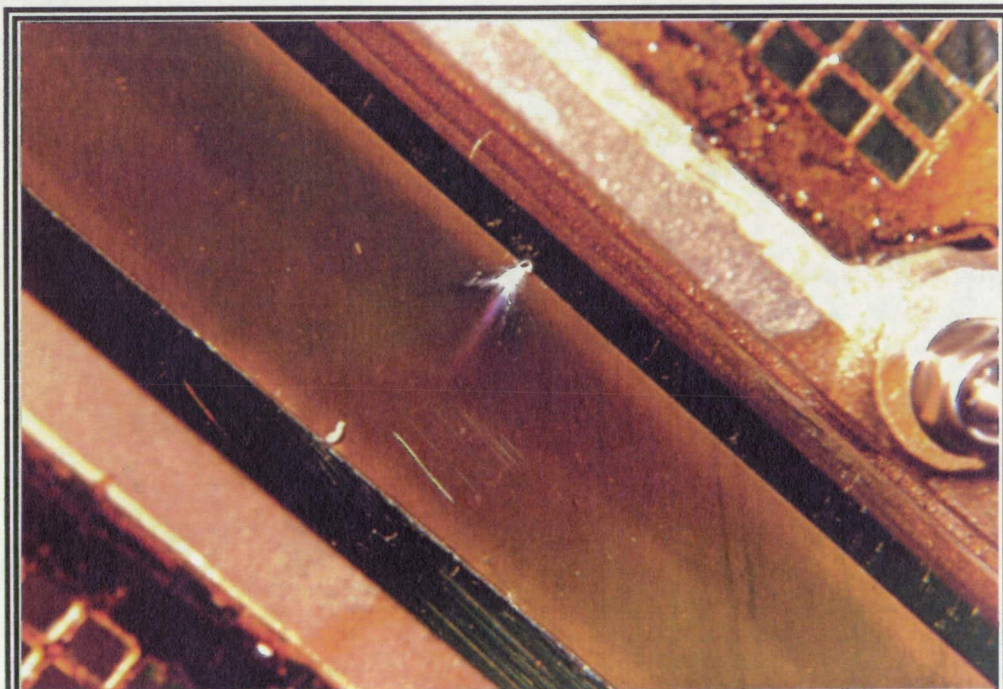
**Figure P2-59.** Photograph of ejecta spray from an impact into a solar cell holder.

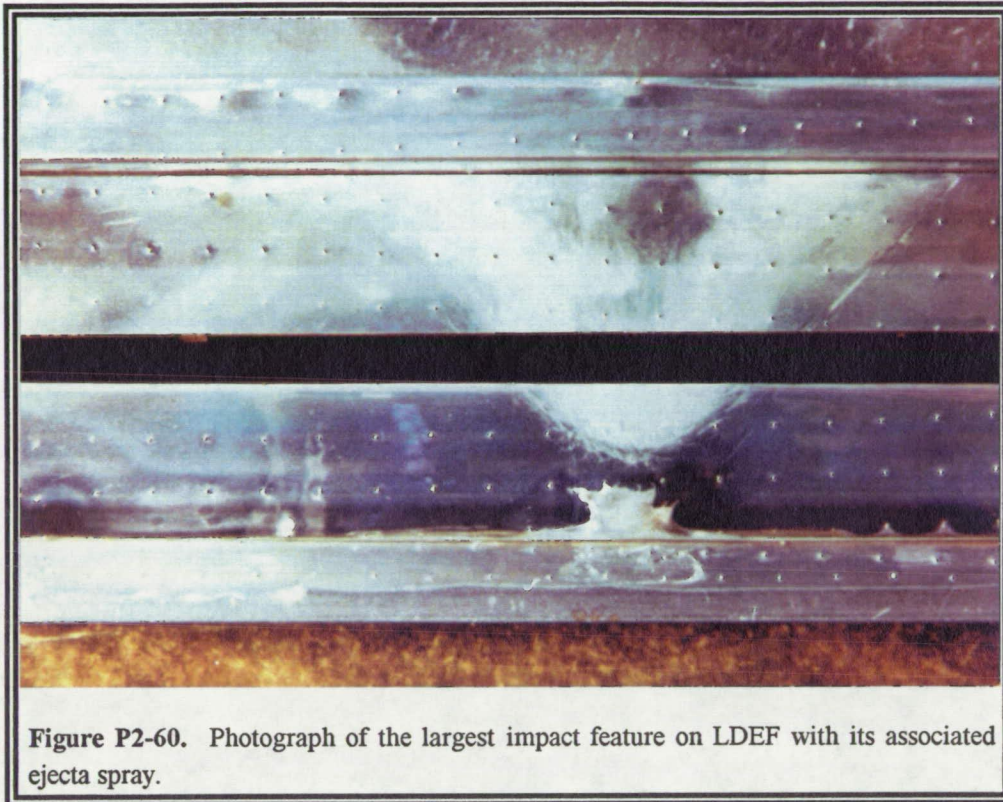
**Figure P2-60.** Photograph of the largest impact feature on LDEF with its associated ejecta spray.
